**Re: Wiring for Eaton Fuller Ultrashift Transmission  
NHTSA Recall No.: 04V-174  
Kenworth Recall No.: 04KW1**

### **FEDERAL RECALL CAMPAIGN 04KW1**

**W900, T600 AND T800 MODELS BUILT AT THE KENMEX FACTORY FEBRUARY 5, 2003 THROUGH JANUARY 13, 2004 WITH AN EATON FULLER ULTRASHIFT TRANSMISSION**

**04KW1 Recall**  
**Start Enable Circuit for Eaton Fuller Ultrashift Transmissions May Be Inoperative**

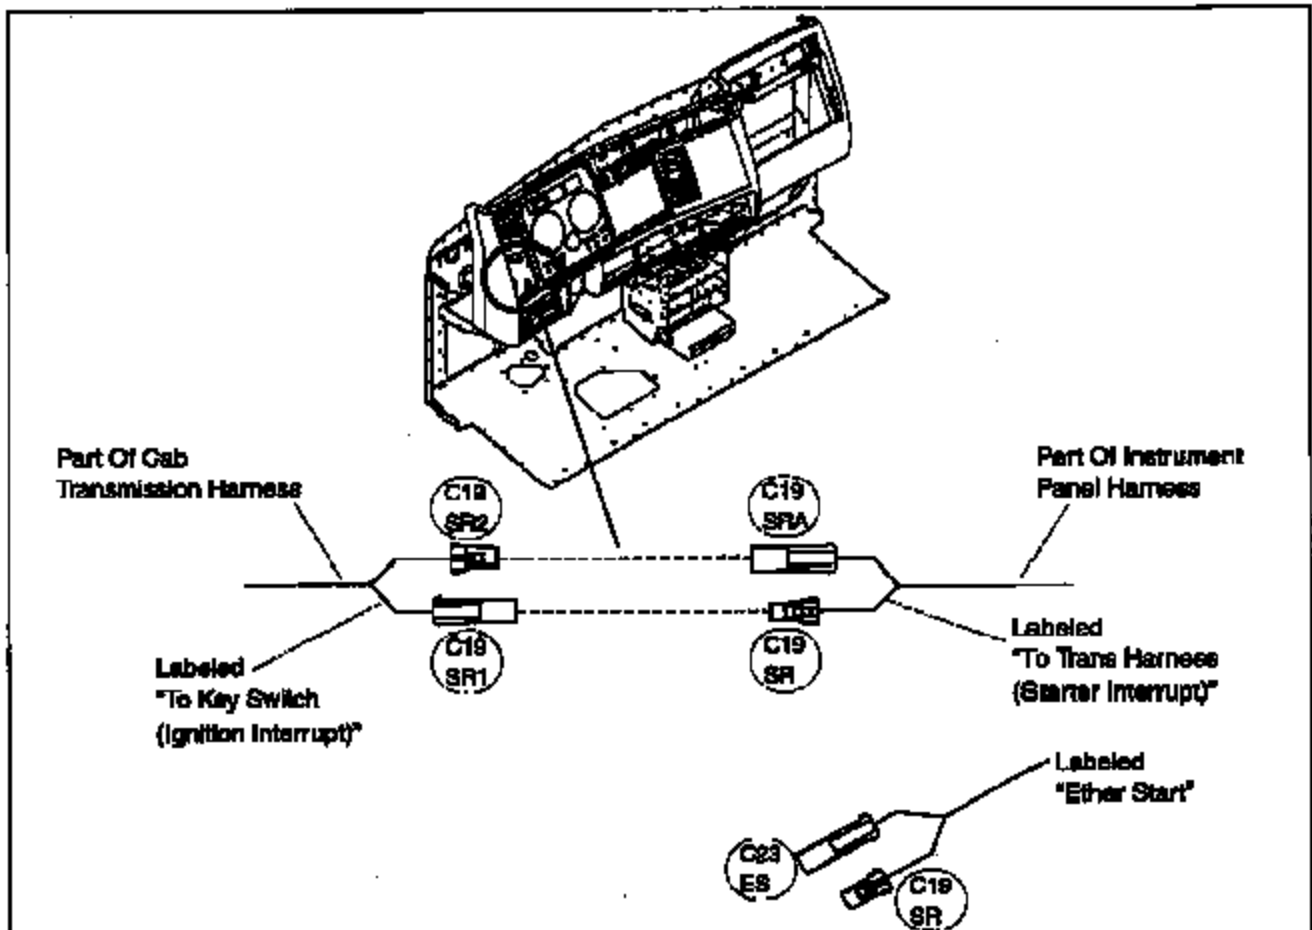
**Figure 1**

Kenworth observed during a vehicle inspection at the KenMex factory that it is physically possible to improperly connect the neutral start circuit of the transmission to the other start circuit of the engine. Failure of the two circuits to be properly connected will disable the neutral only start feature of the transmissions and the truck may be able to start in any gear. Procedures were immediately put in place at all plants to insure that the correct connections were being made and the transmission functioned properly before being released from production. The harness has been redesigned to eliminate the possibility of an improper connection between these two circuits.

1. Remove fasteners securing Speedometer/Tachometer panel to dash. Move panel back to gain access to IP harness.
2. From behind dash, locate both cab transmission harness connectors labeled "TO KEY SWITCH (IGNITION INTERRUPT)". See Figure 1.

3. If the "TO KEY SWITCH (IGNITION INTERRUPT)" connectors are connected to the IP harness connectors labeled "ETHER START", disconnect them.
4. Reconnect the "TO KEY SWITCH (IGNITION INTERRUPT)" connectors to the IP harness connectors labeled "TRANS HARNESS (STARTER INTERRUPT)".

**NOTE:** Tie back the "ETHER START" connectors to prevent any future technician mis-wiring.

5. Perform Transmission Start Enable Operational Test again to ensure engine will not start when the transmission is in a forward or reverse gear.
